Case History - Burn Over Diamond Mill

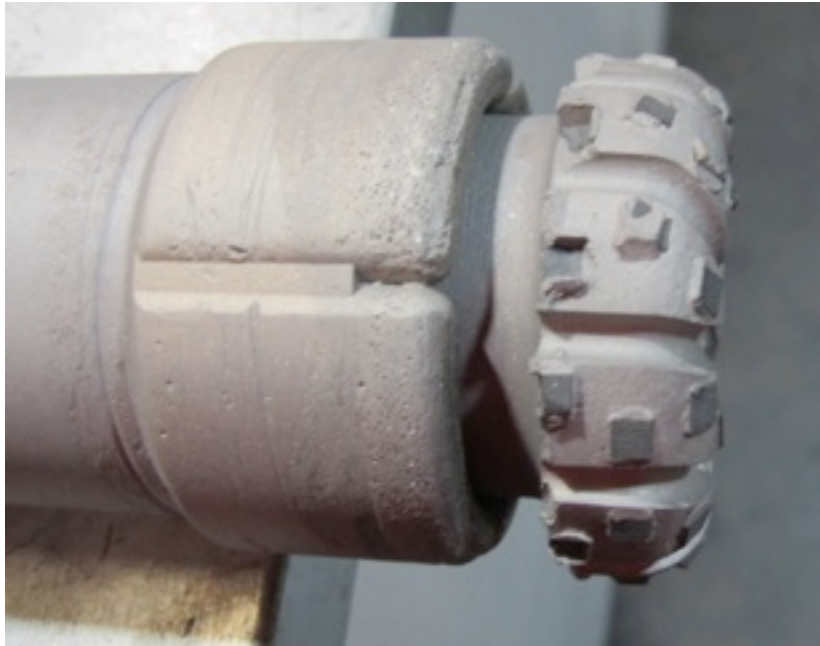
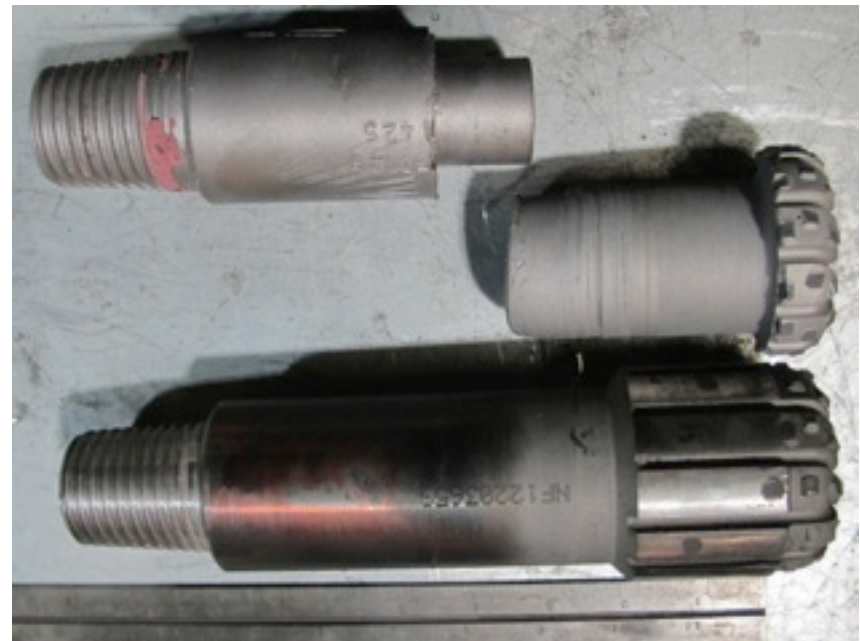
The target was a 2.550" matrix body diamond mill left down hole because of a parted weld with loose carbide on top from previous caribe shoe and mill runs. The XDS shoe burned over the loose junk and 2" of diamond-set matrix gage in 5 hours on motor/CT
