Case History: Vicerou Petroleum. LLC

Target: Carbide Mill stuck on top of fish with loose carbide packed in annulus on top of the mill.

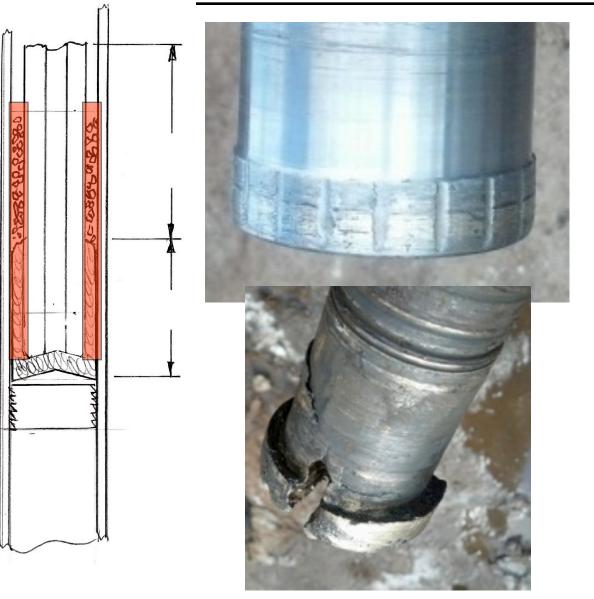
Result: Total 14 hours cut about 6" of mill carbide gage and released. (no progress at 500 #WOB)

Wear on shoe about 20%

Shoe Run: 2.850" x 2.250" SXDS thinwall diamond shoe run on jointed pipe with 1000 to 1500 # WOB and 120-140 RPM.
